# INDEX MAP AND GAMMA LOG CROSS-SECTIONS, SECTION A

**Subsurface Characterizations of Selected Water Bodies in the St. Johns River Water Management District, Northeast Florida**  
Jack L. Kindinger<sup>1</sup>, Jeffrey B. Davis<sup>2</sup>, and James G. Flocks<sup>1</sup>  
2000

This sheet is Section A page 9 of Open-File Report #00-180 prepared by the U.S. Geological Survey Center for Coastal Geology and the St. Johns River Water Management District. For a detailed description of methods, site locations, explanation of regional geology, physiography, karst development and karst features identified by seismic profiling, refer to pages 1 through 7.

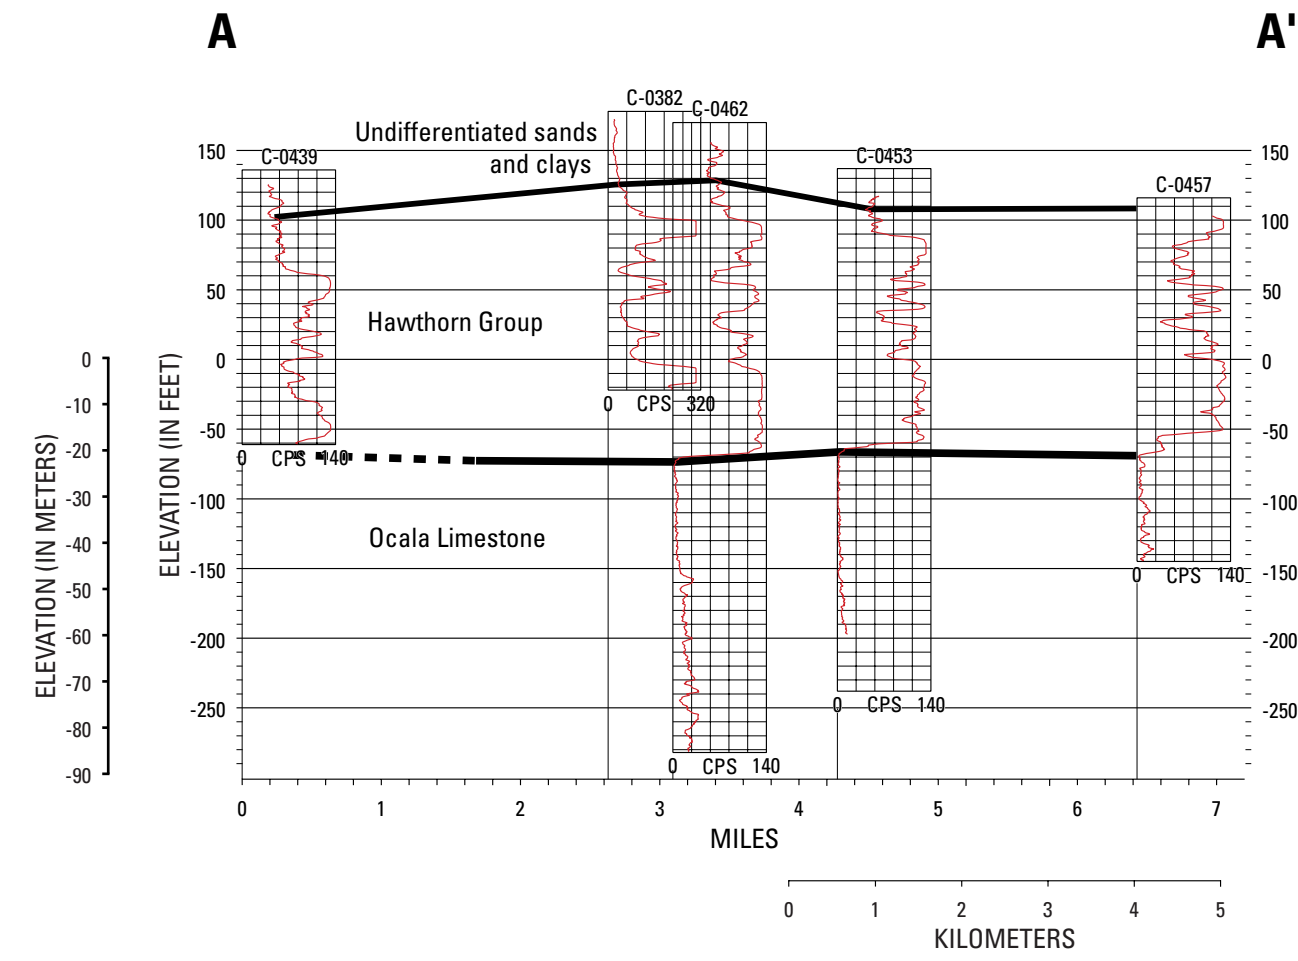
Location of survey area right (red square). Shaded relief map below showing physiographic regions, and location of wells and gamma log cross-section. Gamma Log cross-sections (left) show geologic contacts for correlation to seismic sections.

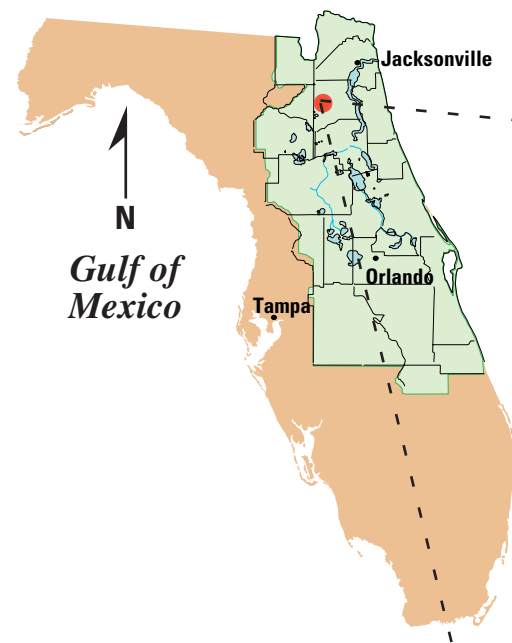
Profile A-A' illustrates the strata in and around the primary sinkhole within the lake. An abrupt change in the lake bottom slope can be seen on the flanks of the sinkhole. This is a filled, collapse-sinkhole with steep flanks overlain by offlapping fill and slumps. The fill is acoustically transparent with few low-amplitude reflections discernible. This is to be expected since the source of the fill is primarily clean quartz sands brought in from the adjacent Trail Ridge deposits. Plotted on the Kingsley Lake survey trackline map are the karst features identified from seismic profiles; Types 1, 2, 3, and 6 karst features were found. Features 1 and 2 represent the primary sinkhole surrounded by Type 6 undisturbed depositional layers. The Type 1, 3 feature seen in Profile B-B' appears to be a secondary collapse feature that occurred after the formation of the main doline shown in Profile A-A'. Unlike the main doline, this feature is not completely filled with sediment. The data does not indicate that the feature extends through the surficial and Hawthorn Group sediments into the Floridan aquifer (>95 m). There is only limited borehole data available to correlate the seismic data. Interpolating from the nearest borehole C-0478 (Index Map A, page 8) the top of the Hawthorn Group is seen along the shallow flanks of the lake at

approximately 10 ms. In Profile A-A' the top of the Hawthorn Group is shown to be steeply dipping towards the center of Lake Kingsley due to the sinkhole collapse. It is estimated that the top of the Floridan aquifer should be seen in the data at approximately 150 ms. None of the profiles contained data that was resolvable at that depth however. Processes that control lake development are:

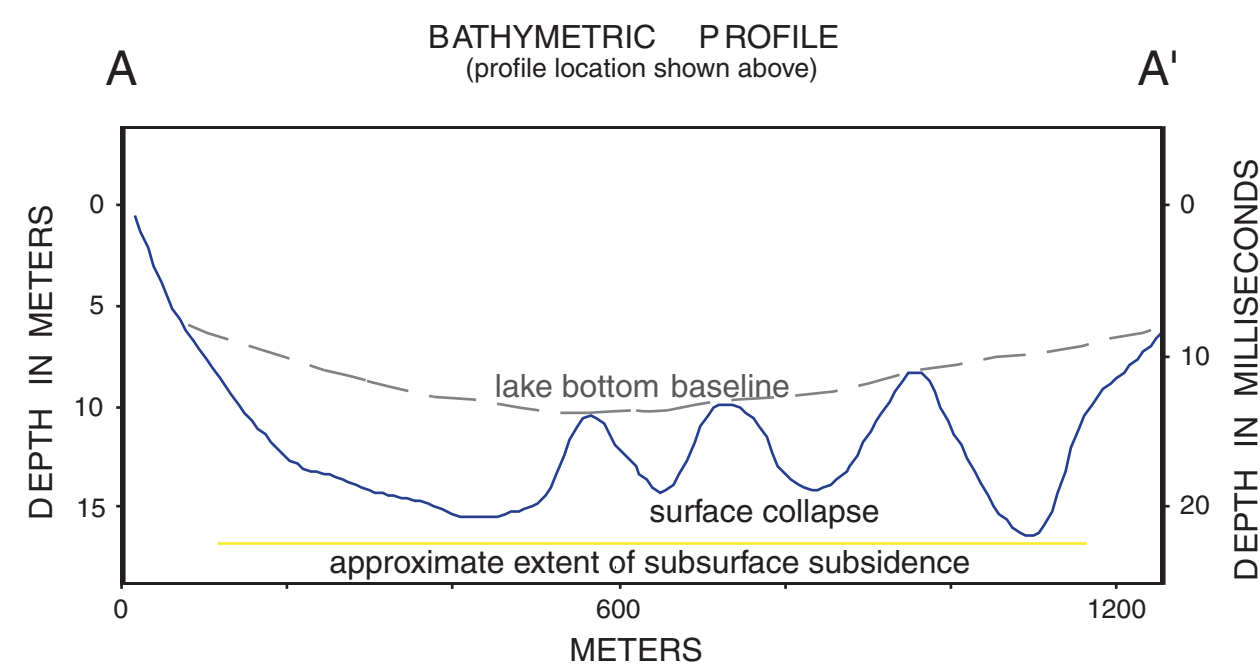
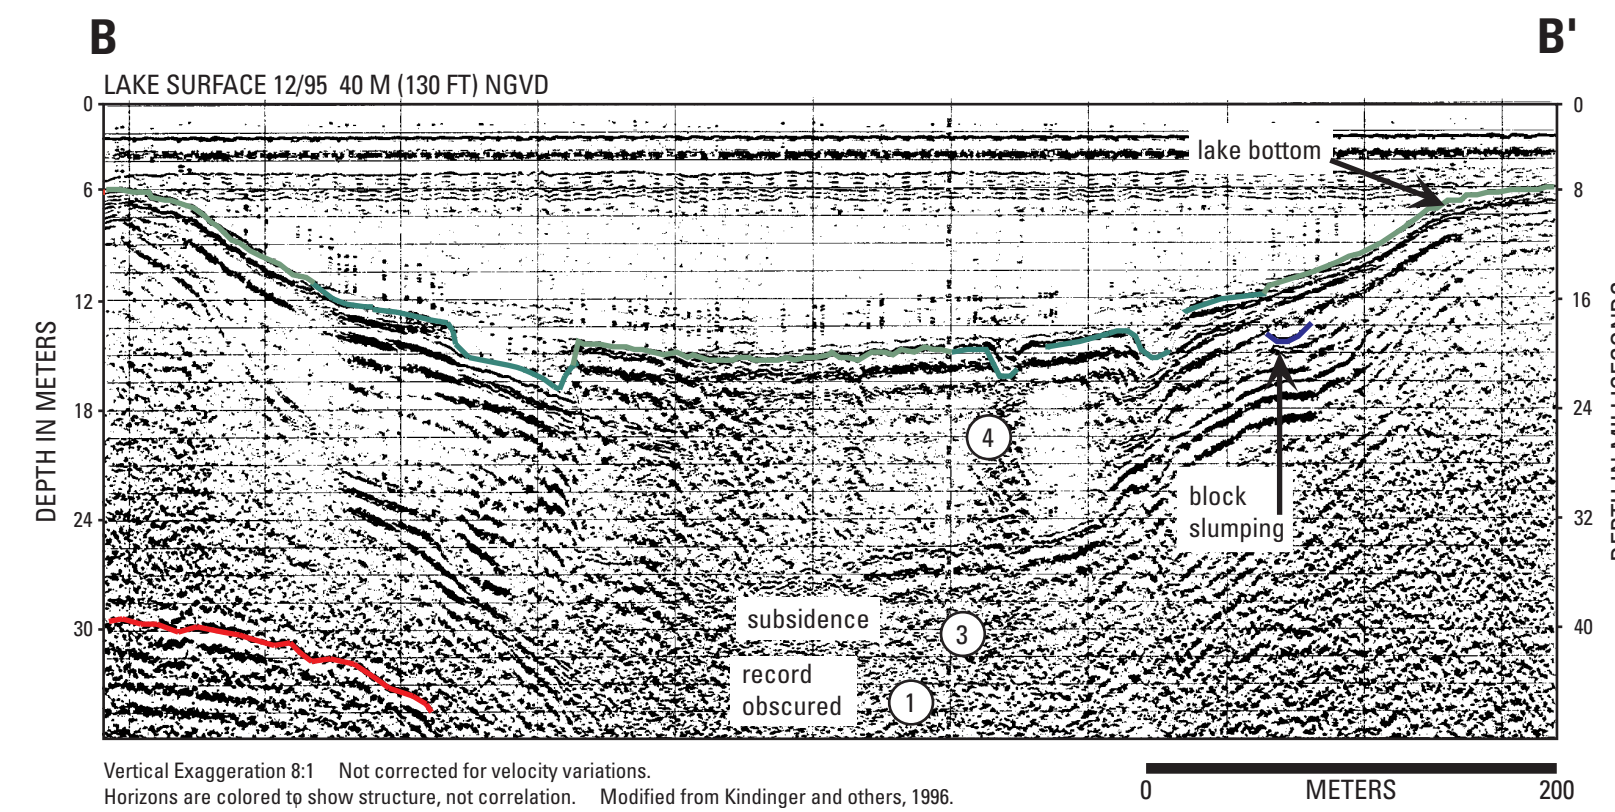
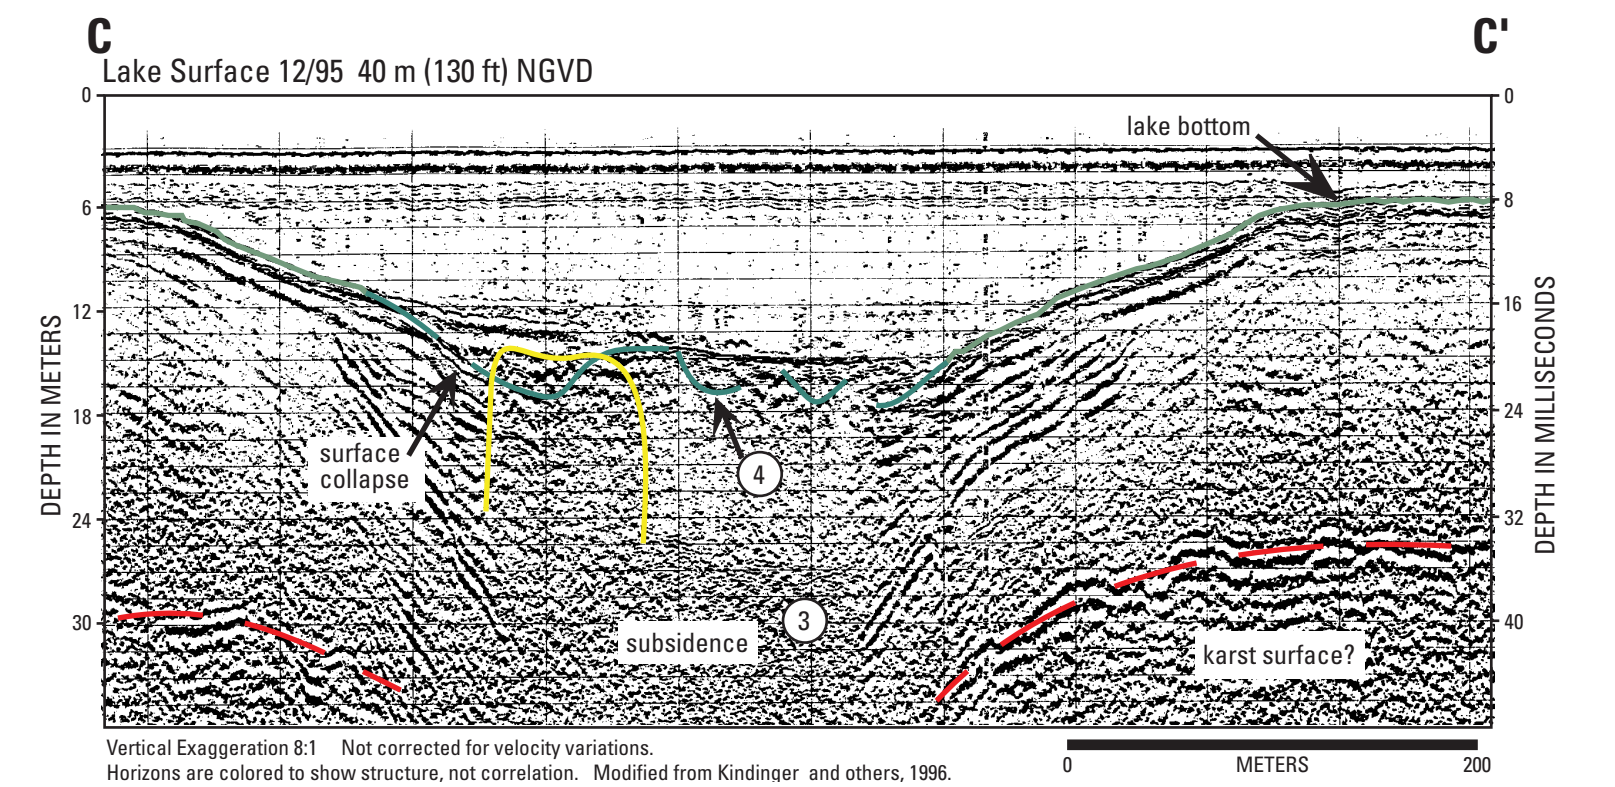
Blue Pond appears to be a single large depression, (see seismic profiles B-B' and C-C'). Many lakes surveyed in this area all appear to have this characteristic (i.e. single basin, single sink), whereas others occur as a complex of depressions. The steep sides of these lakes infer they are young and in the active subsidence or collapse phase (Kindinger and others, 1998). At depth, a strong subsurface reflective horizon at about 30 m below lake level (C-C') is interpreted to be the karst surface. However, interpretations of gamma log profiles to the south put the top of the Ocala Limestone at nearly 60 meters below the lake surface. Johnson (1986) a report that the top of the Marks Head Formation at this depth in a well approximately 4.8 km (3 miles) north of the lake. The Marks Head Formation is part of the Hawthorn Group and is characterized as interbedded dolomite, sand and clay. This horizon is collapsed throughout most of the lake as shown in yellow in the bathymetry map below. The subsurface collapse has created general surface subsidence,

as well as slumping of the overburden into the depression (B-B'). Smaller areas of surface collapse are evident at the lake bottom (green line, C-C'). The smaller collapse structures may be a result of accommodation during subsidence, or solution features created by water movement. These surface breaches probably provide pathways for aquifer recharge from the surface waters. The areas of surface collapse have been mapped in red in the contour plot (A-A'). The profile below the contour plot (A-A') shows the relationship between the lake bottom, the surface features and the subsurface collapse. Most of the profiles from the survey are obscured by acoustic noise, which masks returns from structure within the depression. The noise and multiples appear to be related to the shape of the seismic lake which produces ringing in the acoustic return. This signature is relatively common (Type 1) and can be compared with similar seismic returns seen in other lakes in the study area.

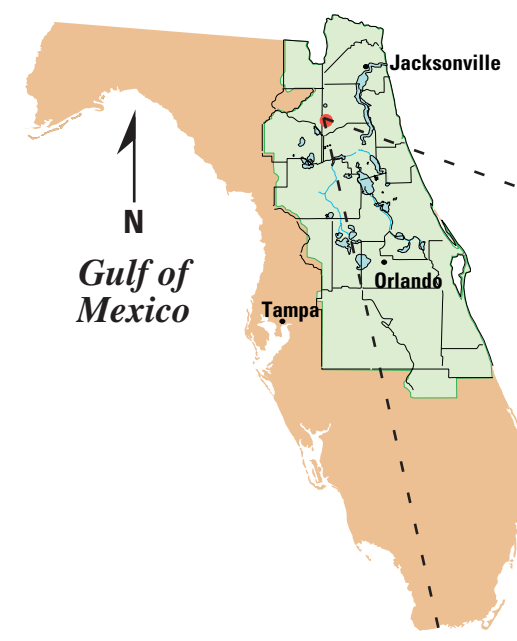
Subsidence features observed from profiles show two areas identified as large (1000 m) subsidence sinkholes (See Survey Track Map). One forms the northwest section of the lake and the other is in the southeast area. Profile A-A' illustrates a large combined subsidence feature that includes buried and active subsidence (Type 2). This cross section shows a variety of depositional fills including cross bedding and onlapping fill. Also found in each profile (Profiles A-A', B-B') is the characteristic pattern of fill and subsidence that indicates rapid subsidence activity and hiatus with slow deposition of sediment. Each of the sinkholes may have developed independently and coalesced over time. Lake Lowry has many of the same characteristic cover-subsidence characteristics found in Orange Lake, but they are much larger.

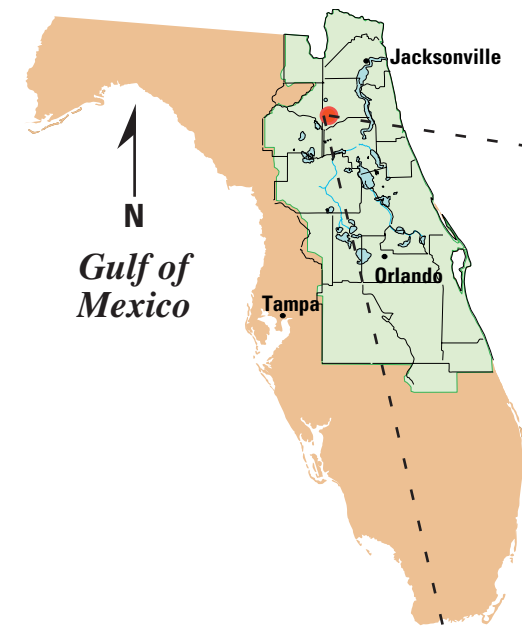
1. Profile obscured by multiples, noise or signal attenuation.

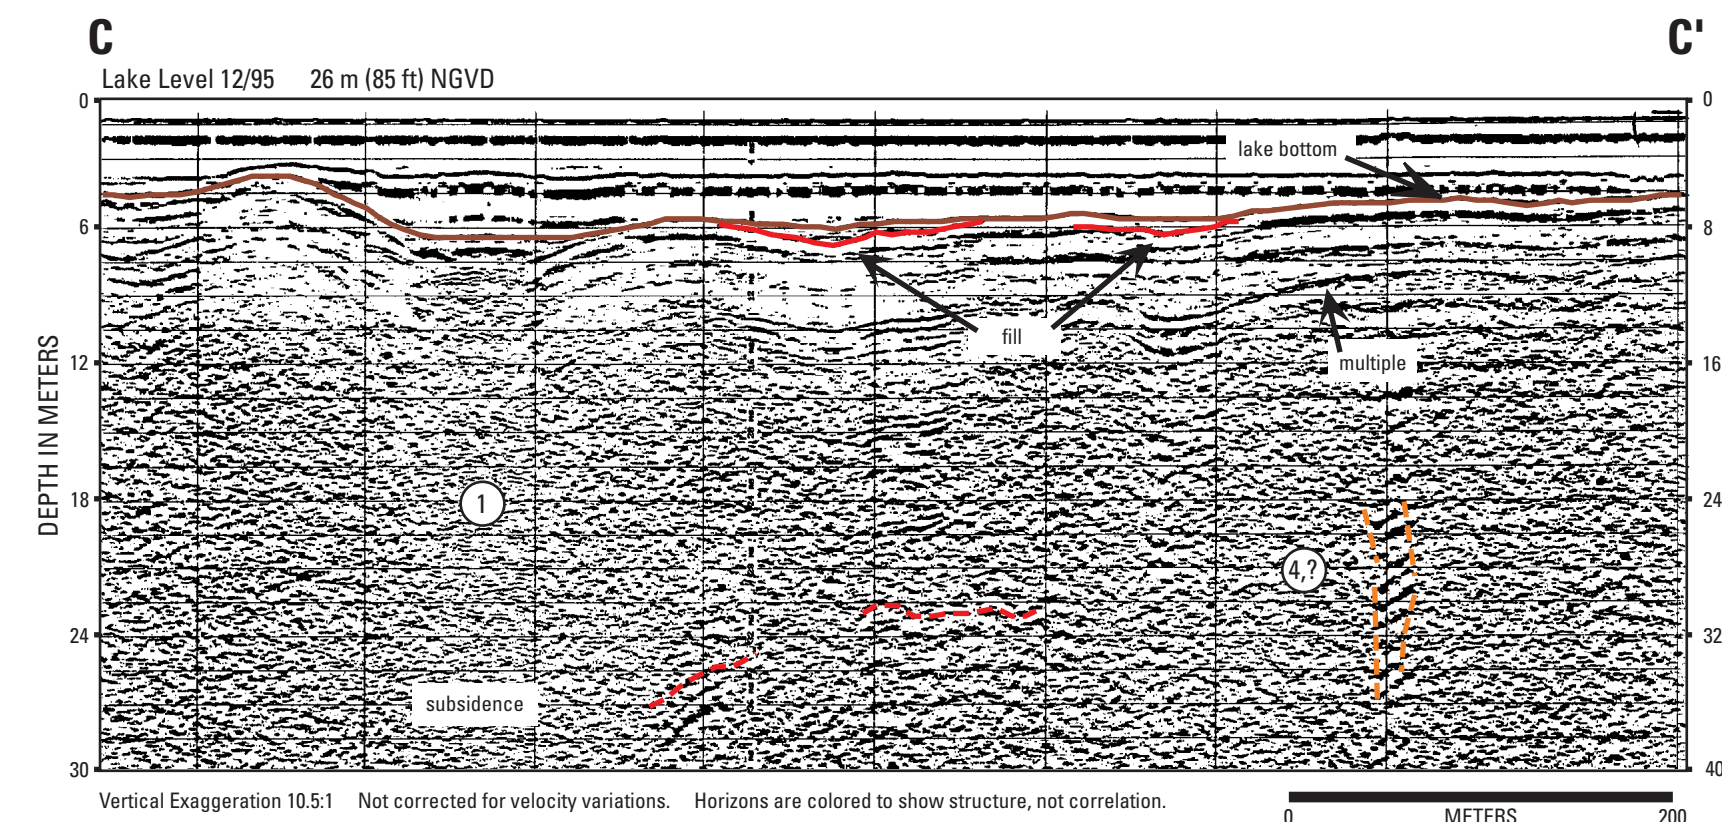
The acoustic signal in Cowpen Lake as a whole is relatively weak. This is shown in the example profiles (A-A', B-B' and C-C'). Factors which contribute to a noisy or weak acoustical return in the lakes of this study area include proximity of hardbottom (limestone) to the sediment surface, accumulation of organic debris on the lake bottom, shallow water depths and proximity, steepness and irregularity of the shoreline. In Cowpen Lake, the nearby and irregular shoreline could create interference (noise) in the signal, and the marshy area in which it resides could produce organic-rich surficial sediments which dampen the return. As a result, little can be seen in the seismic profiles below about 10-12 m. The lake bottom shows an undulating surface marked by localized subsidence less than tens of meters in width. Accumulations of material is imaged near surface in the bathymetric lows (red lines, profiles B-B' and C-C'). This

could represent fill from the surrounding sand hills. In the subsurface, high frequency reflectors occasionally can be seen (orange dashed lines, profiles A-A' and B-B'). These may represent dissolution-type features or disturbed bedding and could indicate breaches in the overburden. The contact between the top of the Hawthorn Group and overlying undifferentiated fill is interpolated to be around 12 m (39 ft) below lake level (see Section A, Index Map). This contact is difficult to detect in the seismic profile because of the signal noise and multiples, but the disturbed bedding at depth would indicate breaches in the confining Hawthorn Group. The top of the Ocala Limestone is estimated to be around 20-30 m (67-98 ft) below lake level (~0 ft NGVD), but is obscured in the profiles. Solution of the limestone at depth could produce dissolution type features which transport material downwards and can create the smaller subsidence areas seen at the surface.
