INDEX MAP AND GAMMA LOG CROSS-SECTIONS, SECTION D

LAKE COMO PUTNAM COUNTY, FLORIDA

Subsurface Characterizations of Selected Water Bodies in the St. Johns River Water Management District, Northeast Florida

This sheet is Section D page 23 of Open-File Report #00-180 prepared by the U.S. Geological Survey Center for Coastal Geology and the St. Johns River Water Management District. For a detailed description of methods, site locations, explanation of regional geology, physiography, karst development and karst features identified by seismic profiling, refer to pages 1 through 7.

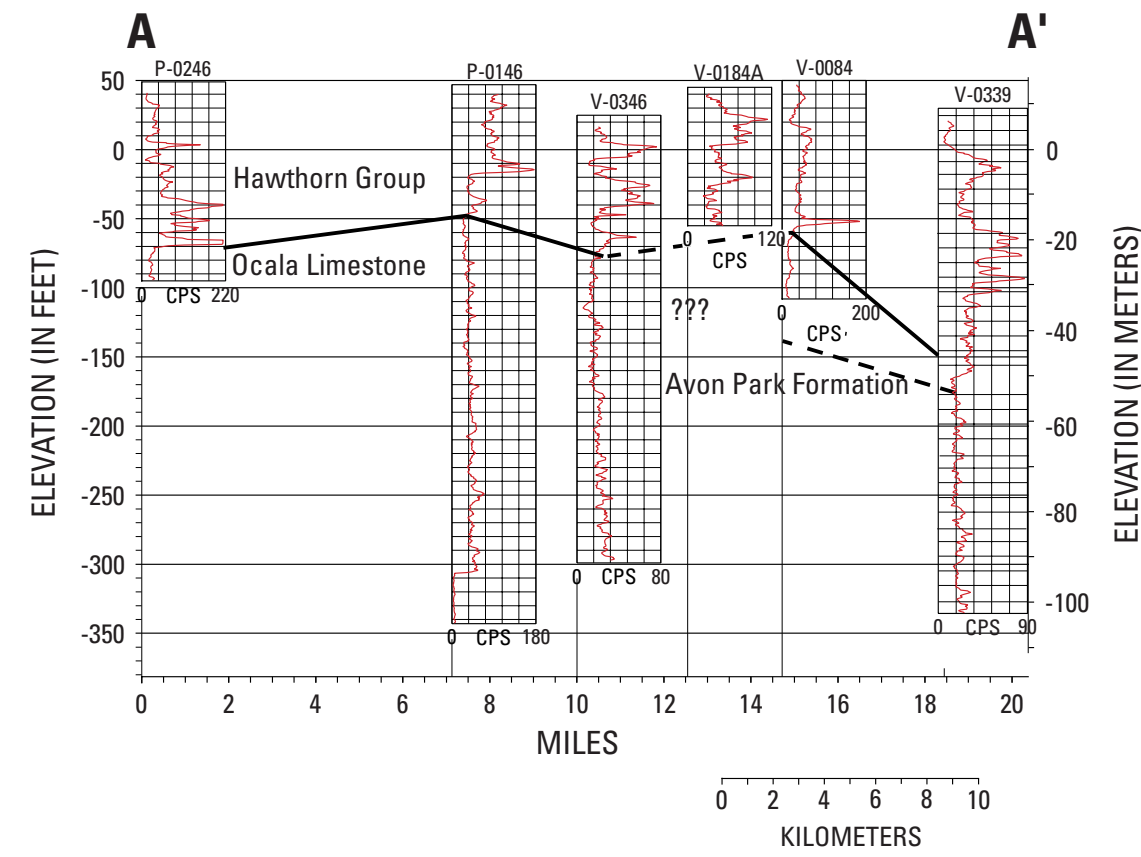
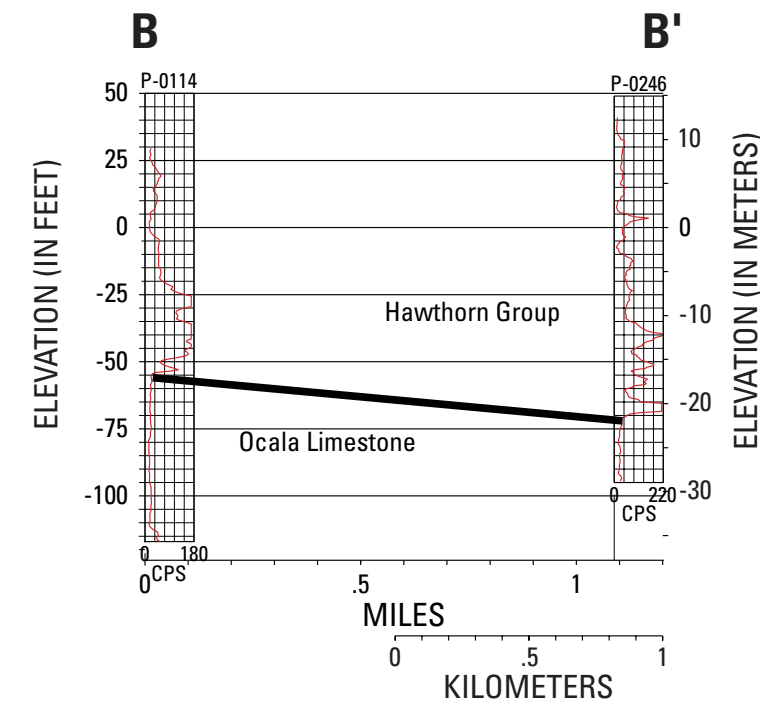
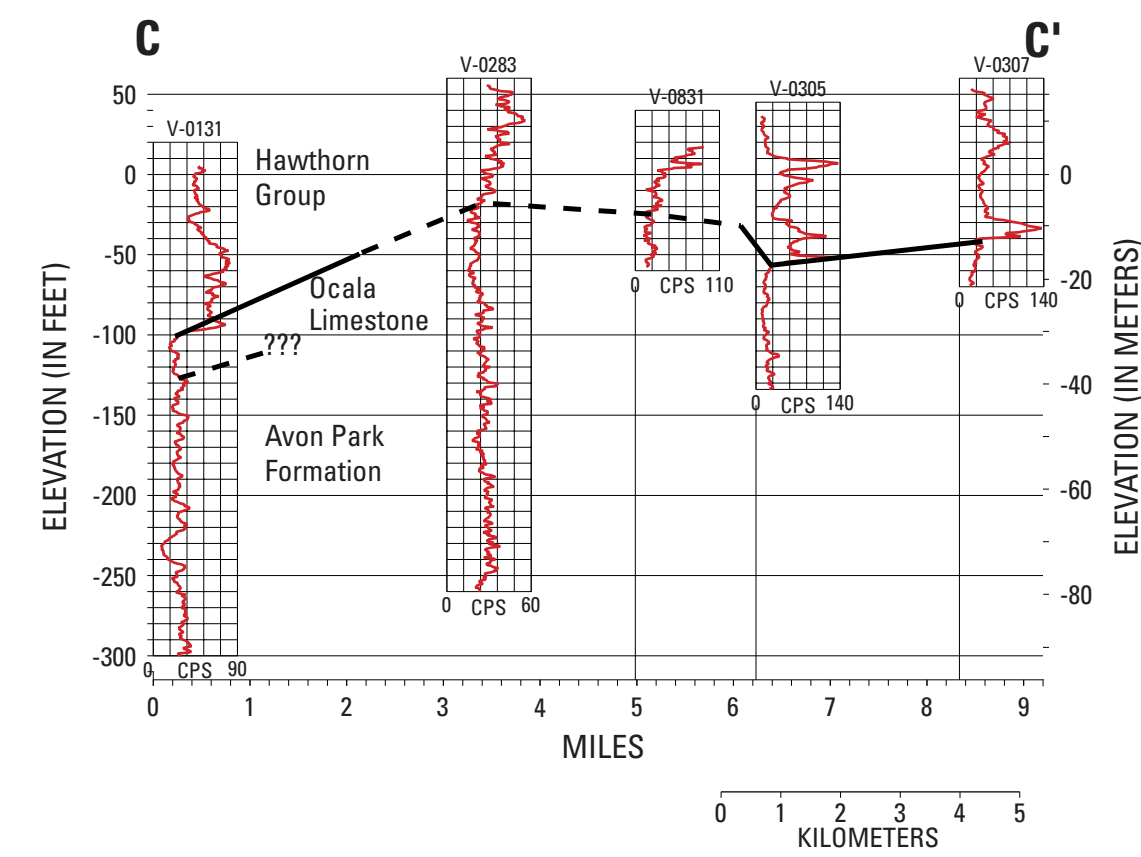
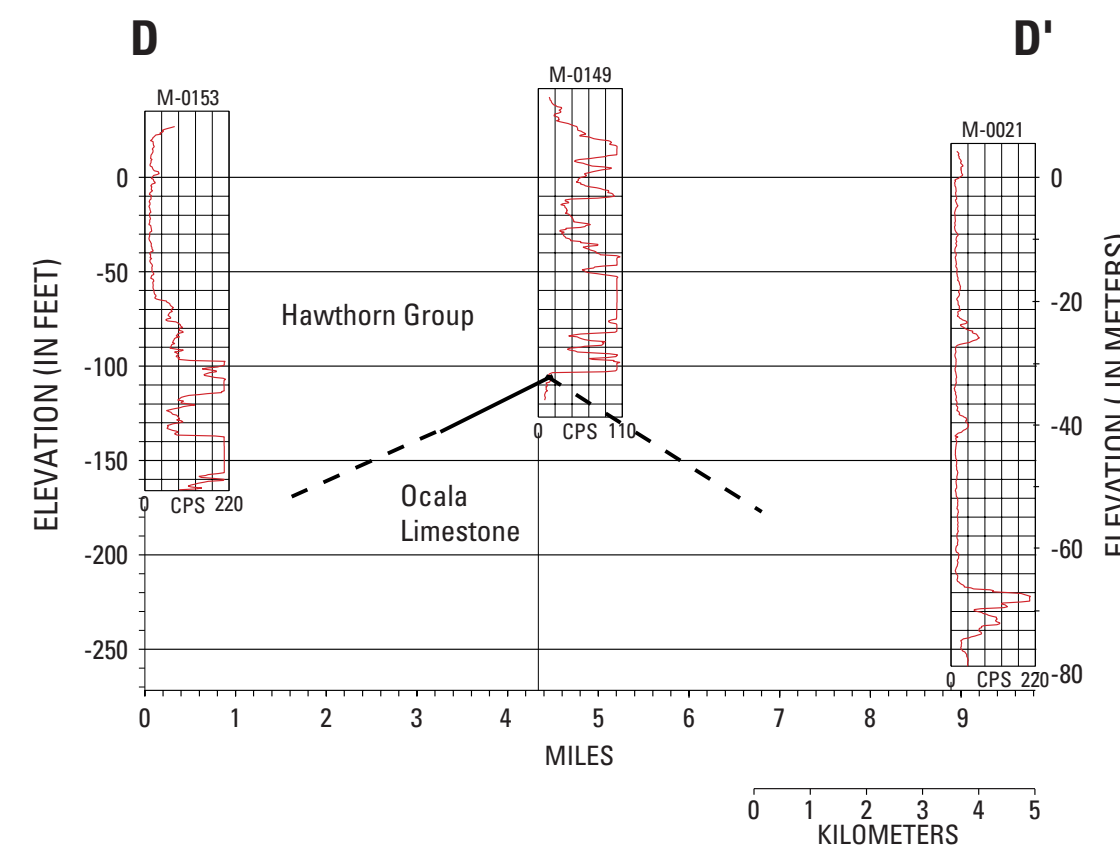
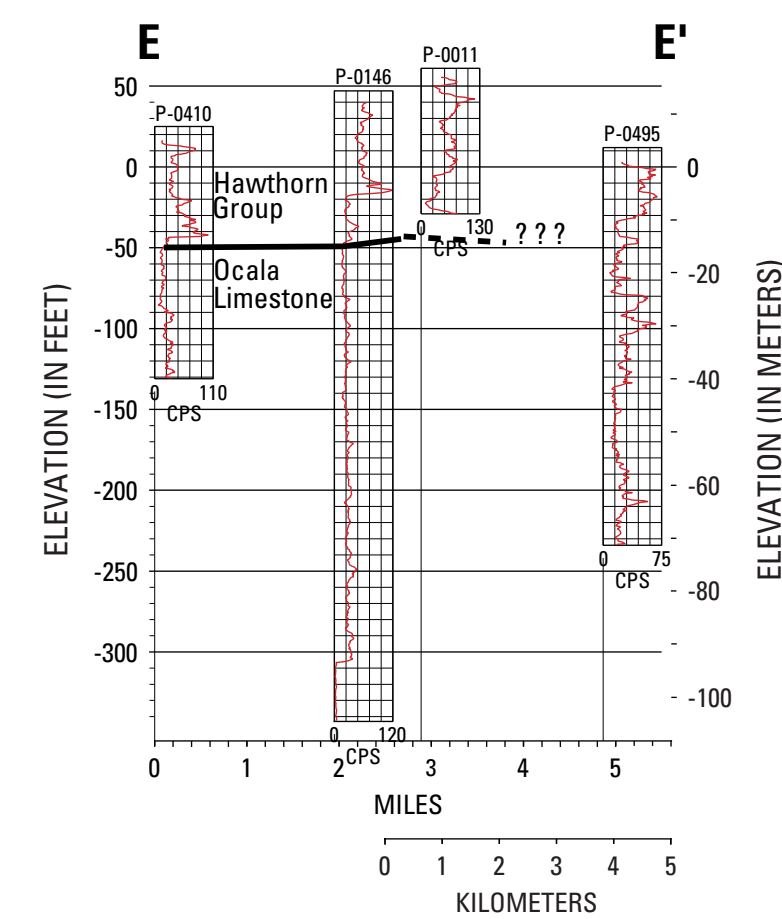
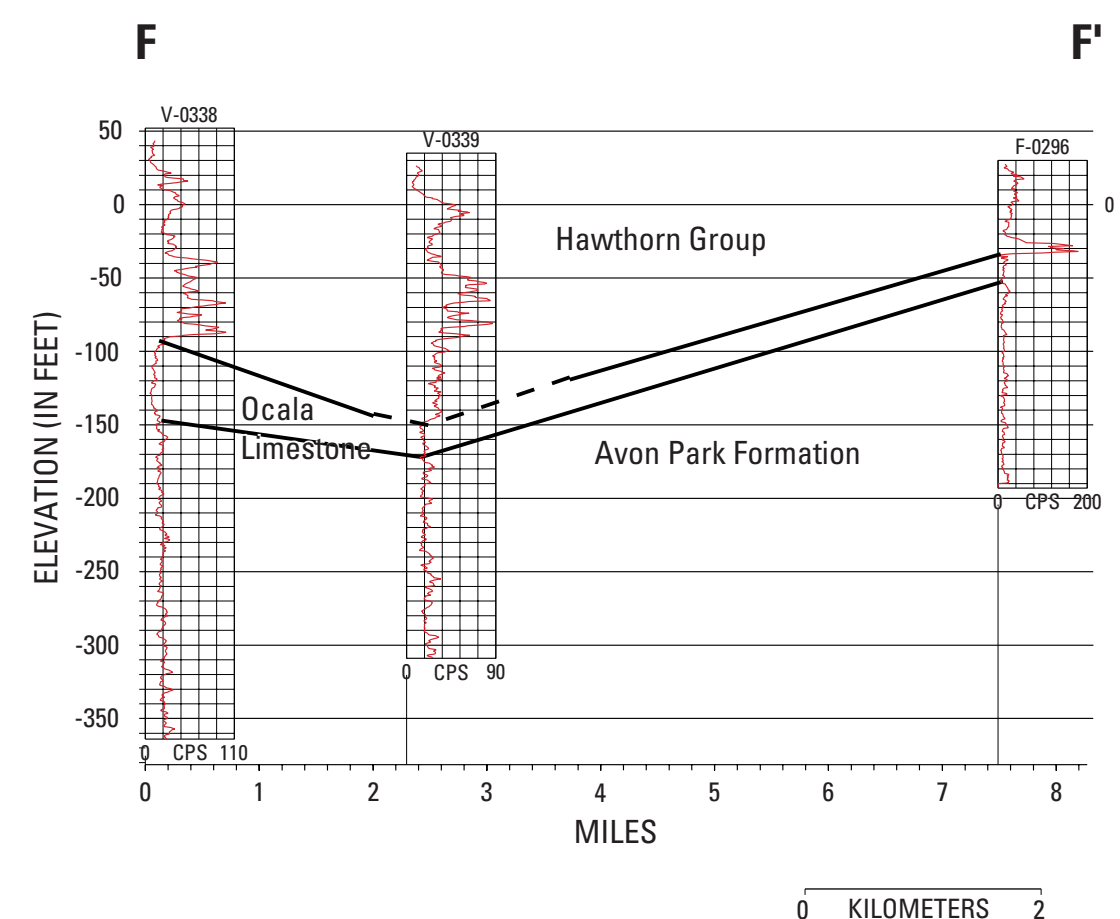
Location of survey area right (red square). Shaded relief map below showing physiographic regions, and location of wells and gamma log cross-section. Gamma Log cross-sections (left) show geologic contacts for correlation to seismic sections.

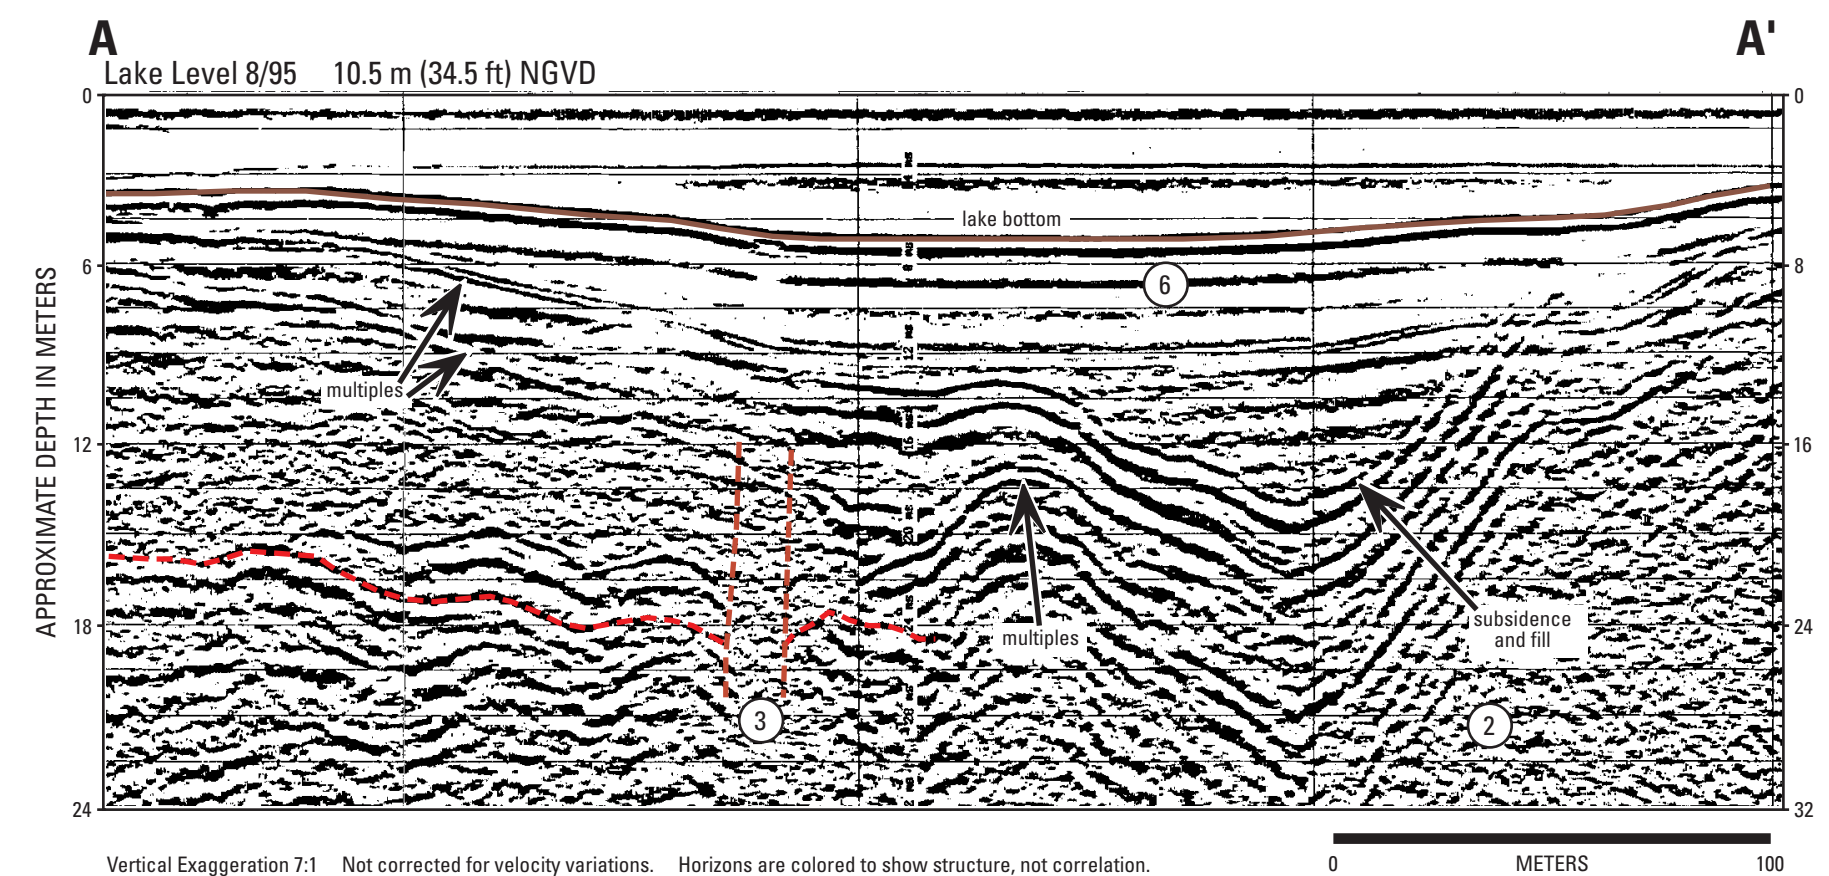
Seismic profiles in Lake Como show many small (>100 m, 328 ft), low angle reflectors overlain and onlapped by horizontal reflectors (profiles A-A' and B-B'). These features represent small-scale subsidence with subsequent infilling. The areas of localized subsidence have been mapped out in the figure showing areas of subsidence. The subsidence features appear to be controlled at depth by collapse in the underlying structure. This is shown in profile B-B' with downwarped reflectors and subsidence-related faulting (type 3). The near surface fill is nearly acoustically transparent and is possibly homogeneous sands from the surrounding sand ridges infilling the depressions. In places the overburden appears to be displaced and rotated as it slumps into the depression (north shore red number 2, Seismic Survey Track Map). Gamma counts from wells in

the vicinity place the top of the Hawthorn Group at about -9 m (-30 ft) NGVD and the top of the Ocala Limestone at about -20 m (-65 ft) NGVD (wells P-0114, P-0246, Index Map D, page 22). The reflector shown as a red dashed line in the seismic profiles may represent a horizon near the top of the Hawthorn Group. Subsidence in the Hawthorn Group sediments, as a result of structural collapse in the underlying Ocala Limestone, would provide recharge pathways to the aquifer. The near surface undifferentiated fill appears to be relatively intact, although some subsidence or breaches may be present as shown in profile B-B'.

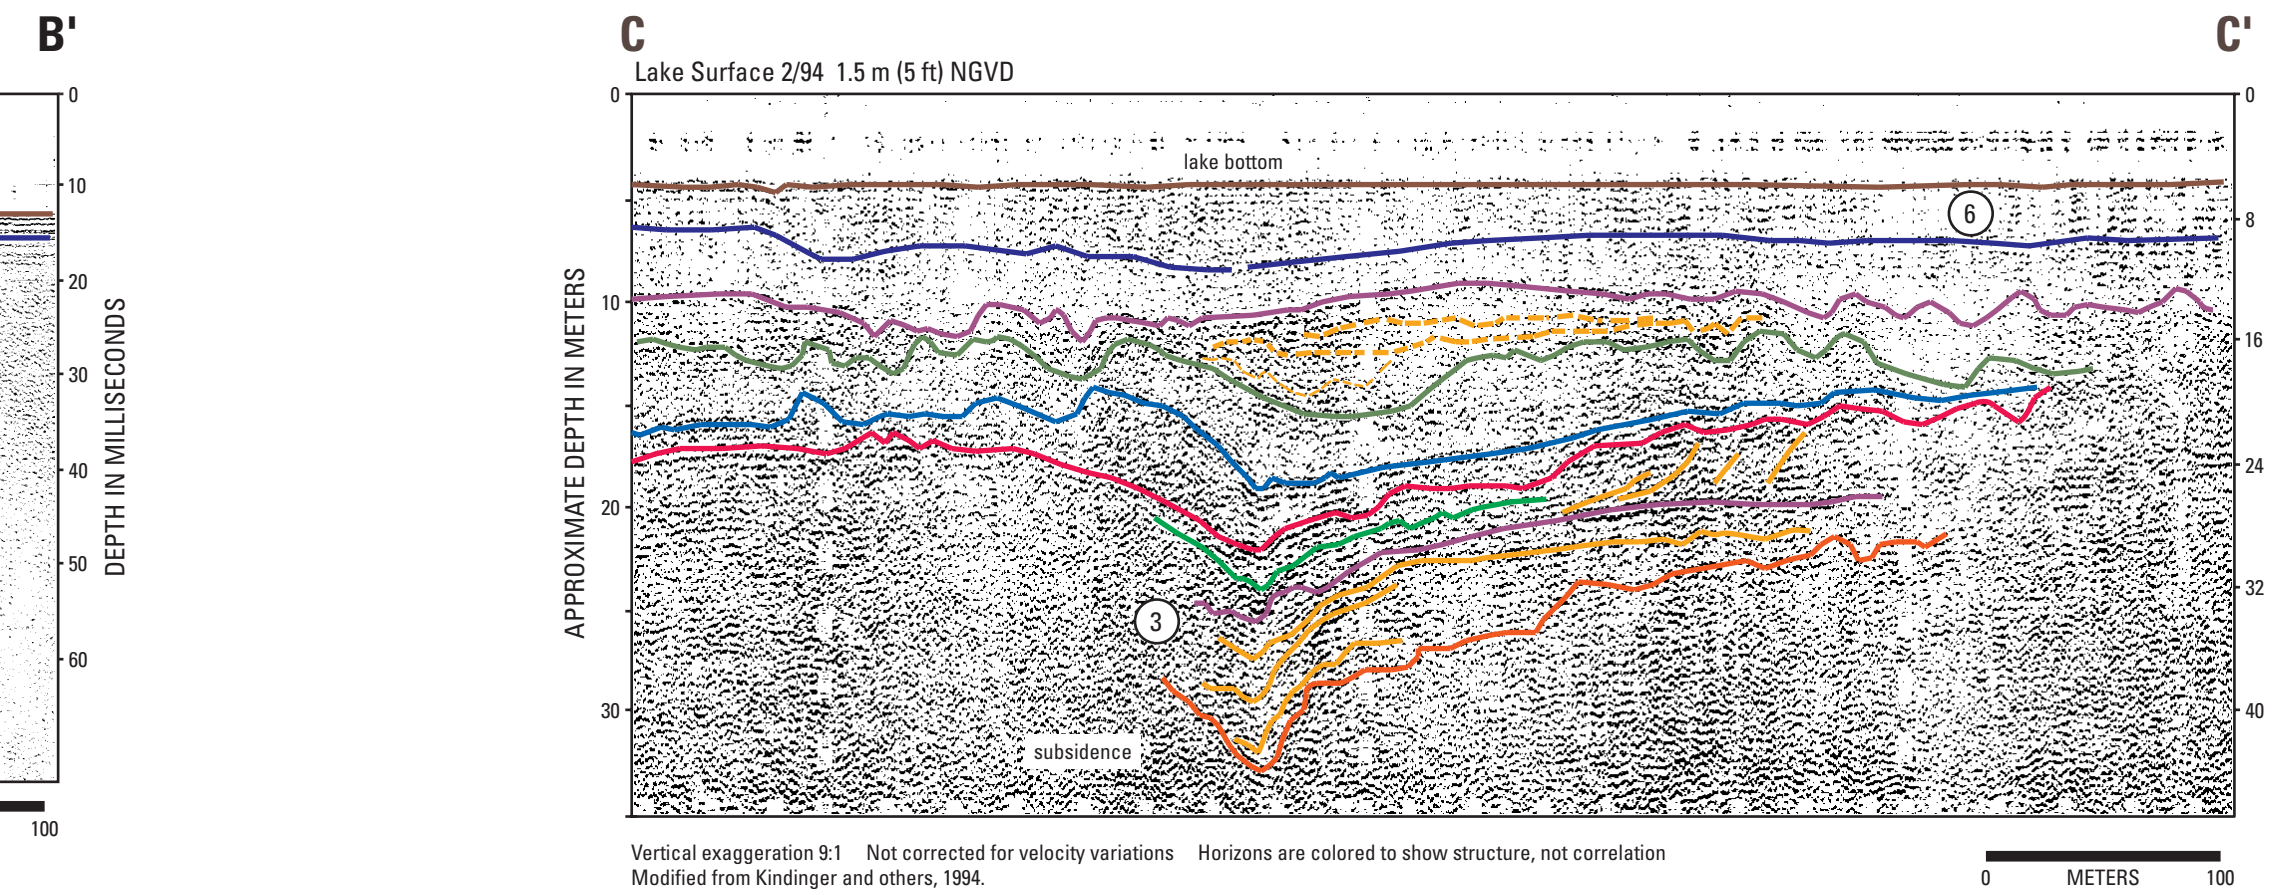
Three example seismic profiles near Drayton Island show several different types of geologic characterization present within the St. Johns River Valley. Karst development in the underlying limestone is accompanied by fluvial-type incised channels, occupying areas of subsidence caused by the loss of material at depth. Profile A-A' shows relatively mature karst development in the limestone, represented by the red dashed line at 30 to 45 m (92 to 148 ft). Gamma log

profiles from four wells surrounding the northern portion of Lake George (P-0410, V-0346, M-0149 and M-0021; Index Map D, page 22) show a highly fluctuating upper contact to the Ocala Limestone. Depths to limestone range from greater than -61 m (-200 ft) below sea level southwest of Drayton Island, to -30 m (-100 ft) to the west, to -15 m (-50 ft) at the lake's eastern shoreline. The variability and range are consistent with the contact represented by the red dashed line on profiles A-A' and B-B'. In profile A-A', a fluvially-incised channel (light brown line) appears to reside over one of the more pronounced depressions in the karst surface. Multiple incisions appear within the channel (orange line) with fill (purple lines). Channel development was apparently terminated and a planing surface (green line) is overlain by a more recent depositional event (solid red lines). This sequence can be correlated to spikes in the gamma counts at -12 m (-40 ft) below sea level (P-0410, V-0346 and M-0149), suggesting a fluvial source, possibly a Pleistocene flooding surface and estuarine deposition, as seen elsewhere within the St. John's Offset (Brooks and Merrit, 1981). These low-angle reflectors are also truncated (dark blue line) and what appear to be recent, riverine deposits occupy the nearsurface of the profile. On the right side of the profile there appears to be another drop in the limestone surface which is also occupied by a channel incision (green lines), but most of this feature is obscured by noise in the seismic record.

Profile B-B' exhibits similar fluctuations to the karst surface, with another incised channel taking shape (brown and orange lines) before being obscured by noise in the record. The truncation surface and subsequent depositional event represented by the solid red lines in profile A-A' are not as readily apparent. It is possible that the orange lines in profile B-B' may be correlative with this depositional event. The more recent hiatus (dark blue line) and overlying fluvial deposits are consistent in both profiles. The relationship of these incised channels to subsidence in the underlying geology is probably geomorphologic; channel development occurred within previously existing depressions and was not necessarily concurrent to karst development.

The shape of the channel incisions and the nature of their fill are similar to buried incised channels observed in seismic profiles acquired from the nearshore shelf environments of the Gulf and Atlantic coasts. The feature outlined in profile C-C' is characteristic of karst-type subsidence rather than a fluvial incision. Again the deepest red reflector may be correlative to the top of the Ocala Limestone, the overlying reflectors may represent subsequent subsidence in the sediments of the Hawthorn Group. Reflectors exhibit subsidence up to the near-surface, suggesting the karst feature in this profile post-dates the fluvial deposition shown in the previous two profiles. The uppermost subsurface reflector (dark blue line) is again overlain by high frequency, parallel reflectors which may be representative of recent fluvial deposition.

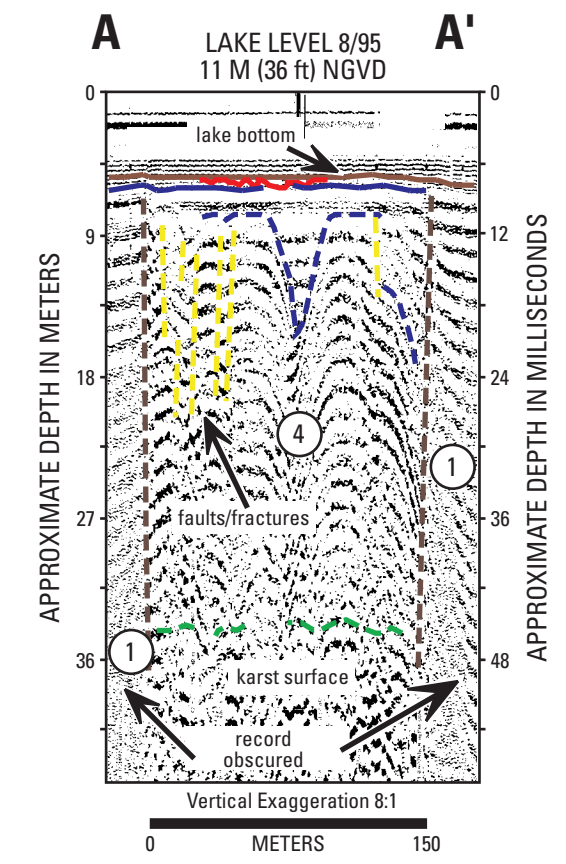
to the subsidence. The northern portion of the lake is characterized by numerous type 4 features (profiles A-A', B-B', C-C'), or a common characteristic where dip in a reflector is apparent but obscured by noise (profile C-C'). The features extend from near the lake bottom to depth and may indicate areas of potential leakage. A horizon very near the sediment surface can be resolved from the data (solid blue line), with infilling (red lines). At depth, a strong reflective horizon is evident between 30-48 ms (dashed green line). The horizon is punctuated by numerous discontinuities and elevation changes. The gamma logs indicate the top of the Ocala Limestone to be at about -15 to -24 m (-50 to -80 ft) below mean sea level, which correlates with this horizon. Dissolution of the Ocala Limestone would cause the subsidence seen in the overlying material of the Hawthorn Group. If the material above the mid-level horizon is impermeable massive clays, the discontinuities represent major breaches across the confining unit. Evidence of the breaches are substantiated by reports from local residents who indicate that a spring once flowed from the northwest section of the lake decades ago (see Seismic Survey Map). The spring was used as a water supply until flow ceased as the majority of the region changed from an area of discharge to recharge to the Floridan aquifer (Boniol and others, 1993).

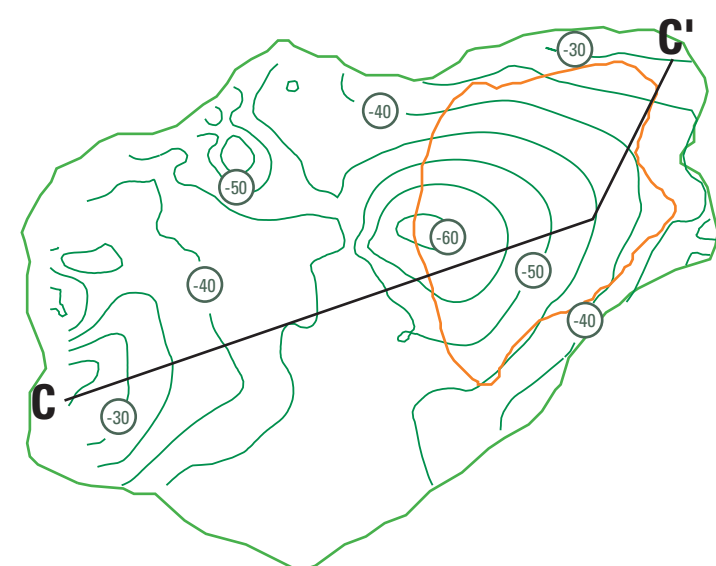
DEPTH TO LIMESTONE

Logs from wells in the area (Gamma log profile sheet, wells V-0339, F-0296) show the depth to the Ocala Limestone to decrease from about -46 m (-150 ft) NVGD east of the lake to about -15 m (-50 ft) NVGD to the west. The reflective horizon represented by the dark green line in profiles A-A' and B-B', correlates with this contact. The variable relief of this horizon, as expressed on the left side of profile A-A', and in the contour plot (Depth to Limestone and subsurface two dimensional profile C-C'), is characteristic of mature karst development and a subsidence sinkhole. Besides the large depression in the east central portion of the lake (Depth to Limestone contour plot), there also appears to be dip in the karst surface to the northwestern portion of the lake. The plot of the intermediate horizon shows subsequent subsidence in the overlying Hawthorn Group sediments.

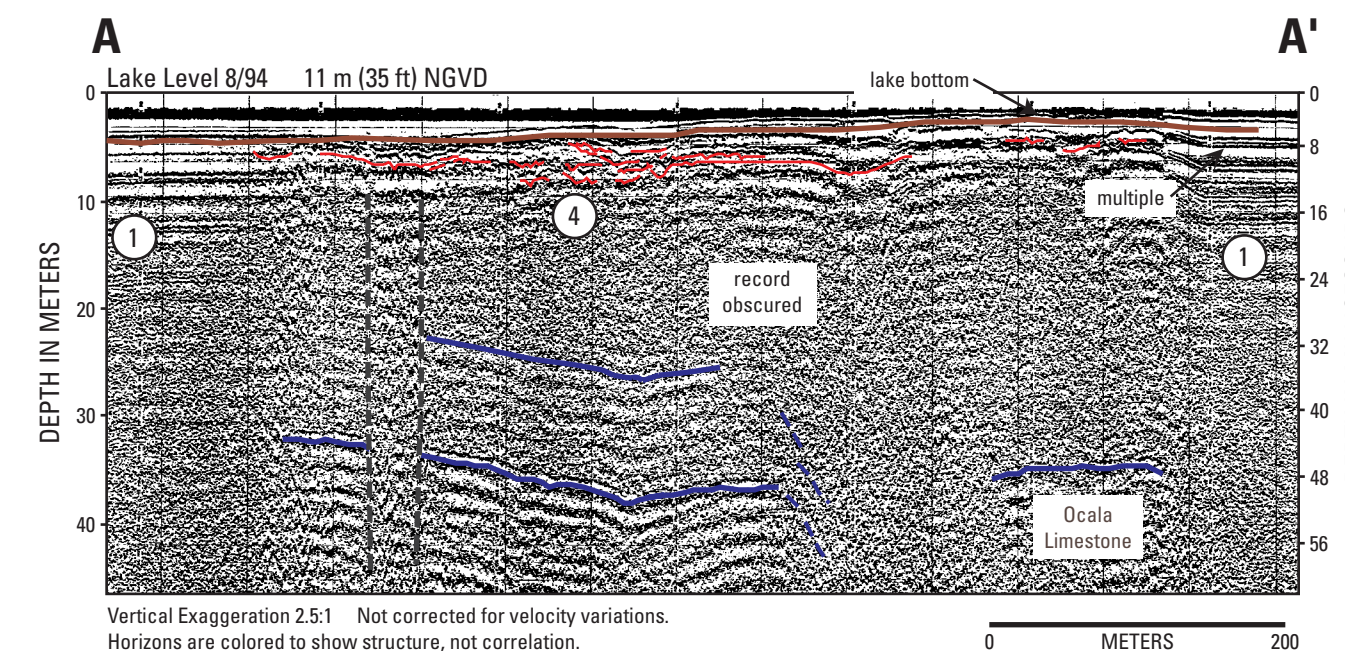
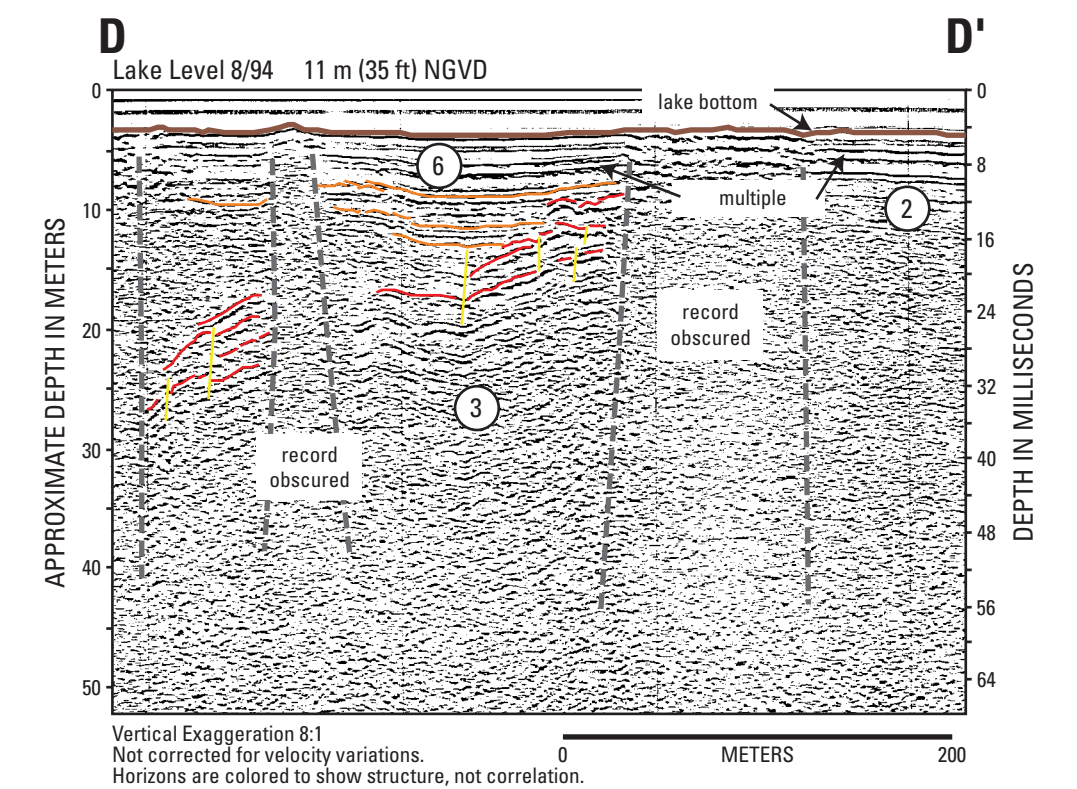
Seismic profiles from Lake Dias are predominantly obscured at depth. A strong bottom reflector leads to multiples seen throughout the data that obscure some of the record in the deeper portions of the lake (profile C-C'). The record is also partially obscured in areas where the lake bottom nears the surface (profile A-A', B-B'). In general the lake is characterized as a single large depression comprising most of the lake (Distribution of Features Map, blue line). Deep reflectors tend to drop prior to becoming obscured near the central portions of the lake (profile B-B', blue lines). This suggests that deep structures influence the lake bathymetry. Low-amplitude, near surface reflectors in some of the profiles near the fringes of the lake have a hummocky appearance (index map, type 4 feature, profiles, A-A', B-B', red lines). The reflectors may represent smaller subsidence features in the fill overlying the deeper subsidence. Profile C-C' also shows some low angle, offlap type reflectors (type 6 feature, red lines) that may represent subsequent fill during subsidence of the lake.

Profile D-D' shows a feature seen in the extreme northeastern portion of the lake. Pronounced high angle reflectors (red lines), overlain by fill-type horizontal reflectors (orange lines) may represent a collapse structure (type 3 feature). A chaotic signal below the horizontal reflectors could be block fill associated with the initial collapse, which was subsequently overlain by fluvial fill. This is the only area throughout the lake where this type feature is present and could represent a major breach in the confining material overlying the aquifer.

Interpretations of Gamma profiles from wells surrounding the lake (Index Map D, profile C-C') show the top of the Ocala Limestone to be between -9 and -15 m (-20 and -50 ft) NGVD. This would correspond to between 26 and 35 milliseconds depth in the profiles, using an averaged sound velocity of 1500 m/s. This depth would suggest that the blue lines seen in the profiles (A-A', B-B') represent horizons near the top of the Ocala Limestone. Dissolution in the Ocala Limestone at depth would cause subsidence in the overlying material and fill.
